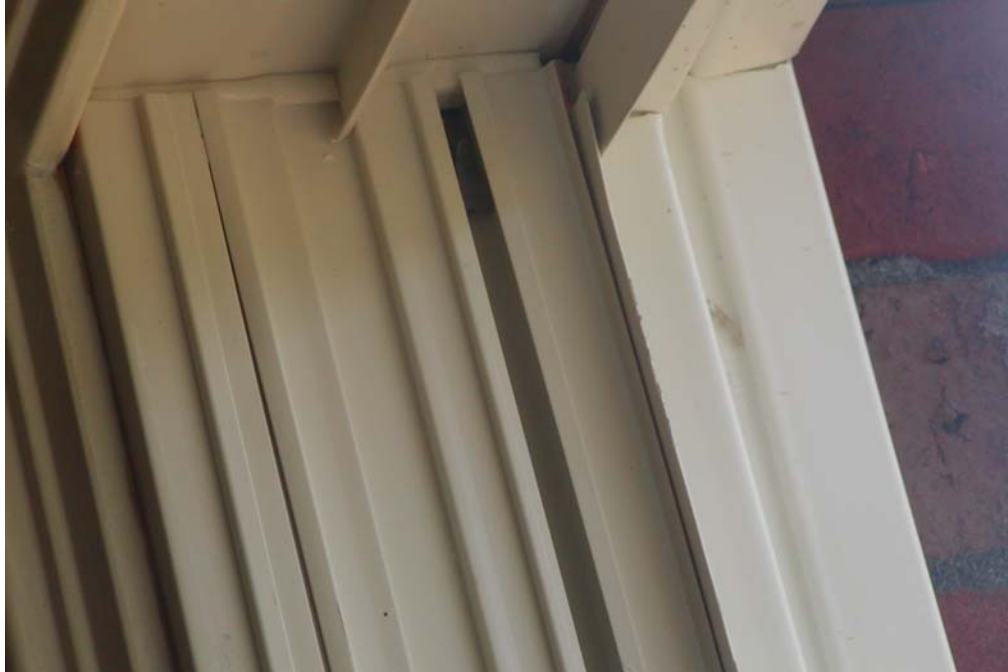
Missing spring in window of Master Suite on left side of room. Spring allows top sash to fall.

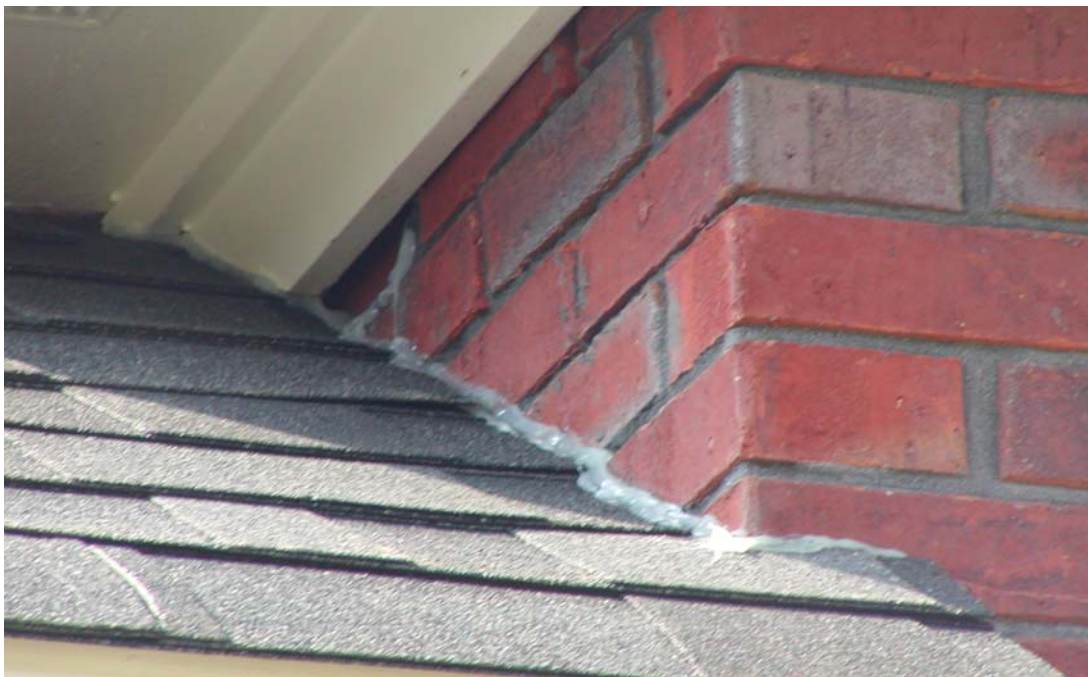
Side wall flashing is missing.

**§RR905.2.8.4 Sidewall flashing.** Flashing against a vertical sidewall shall be by the step-flashing method.

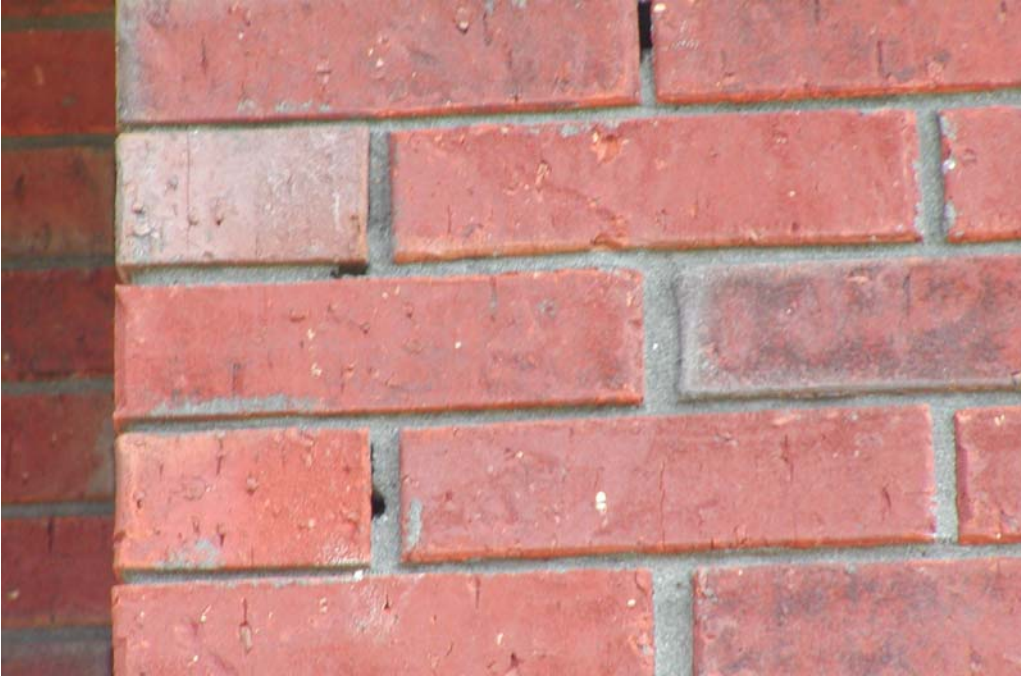
Some tuck pointing is needed in various areas of brick veneer exterior wall covering.

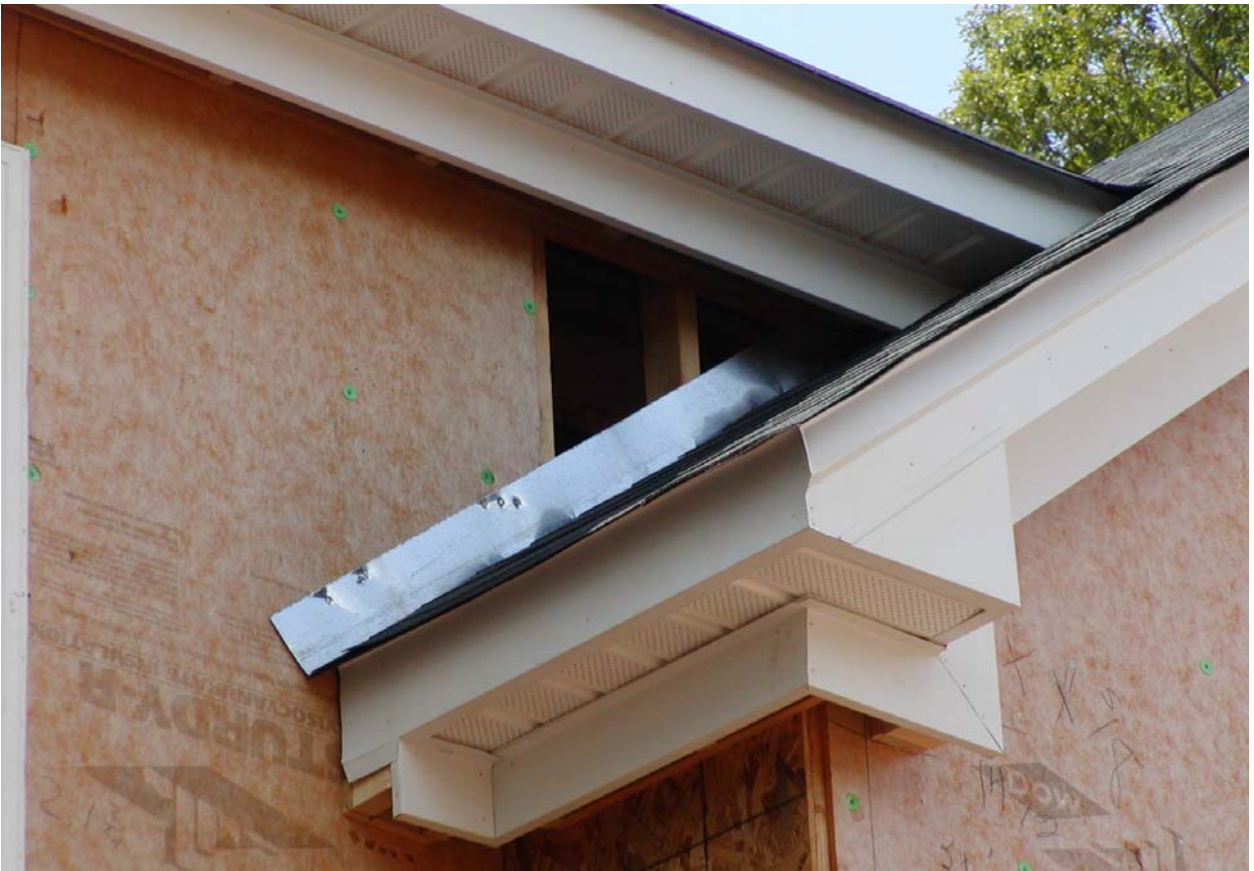
Exterior wall sheathing missing on left side of house.

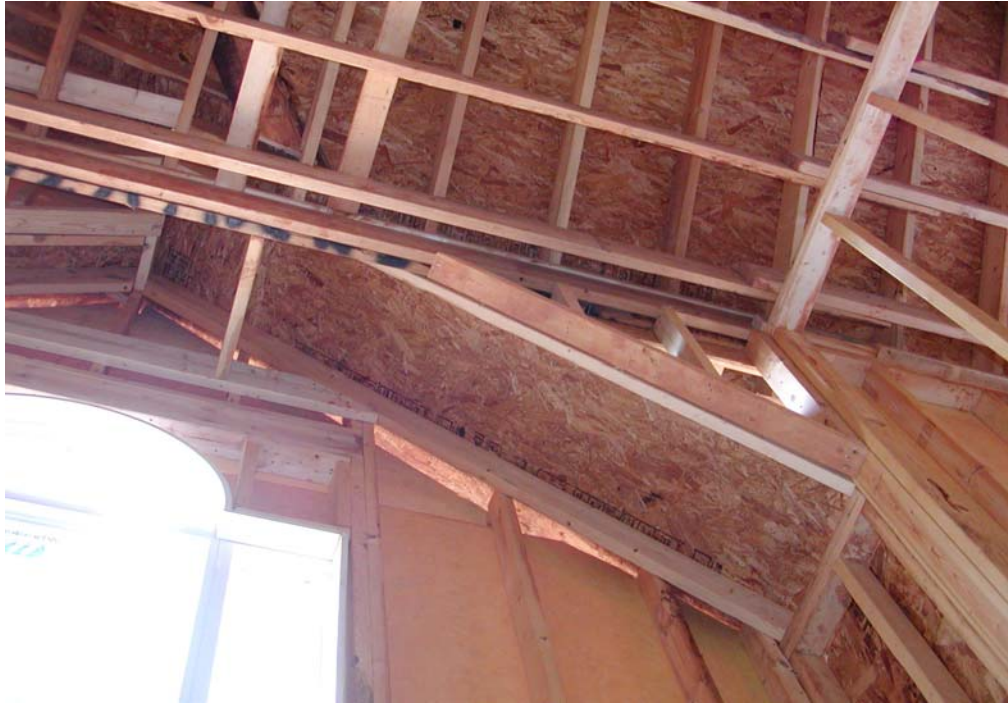
Brick veneer not properly supported by roof construction, additional rafters should be added.

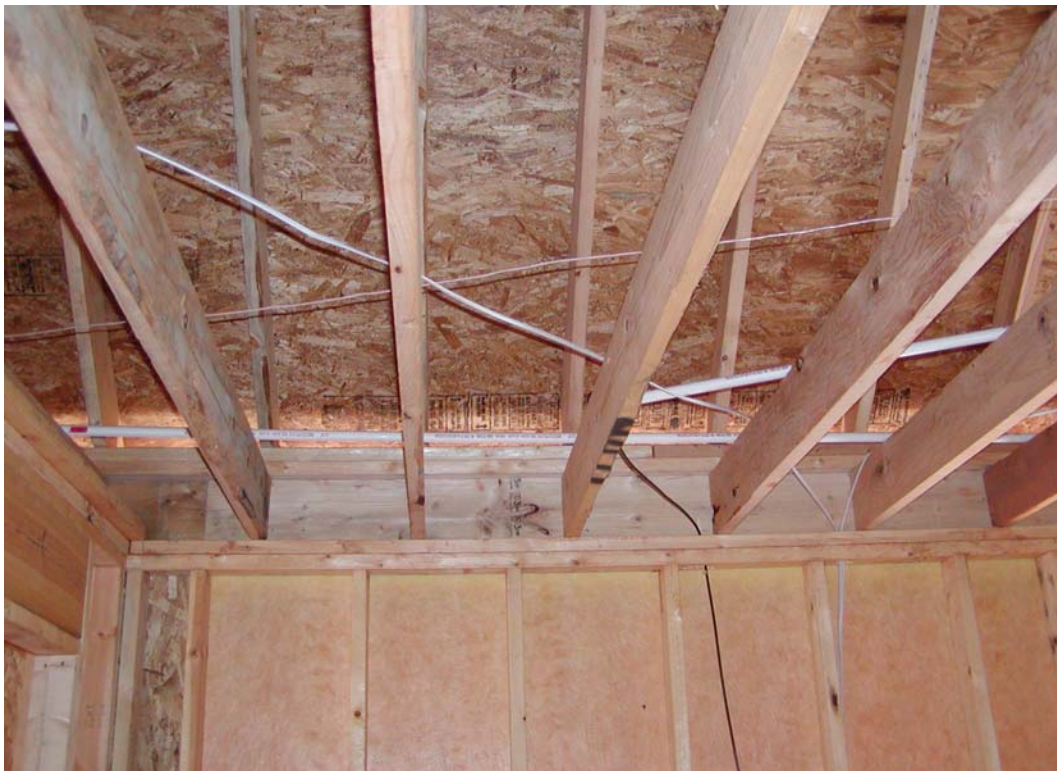
No Rafter Ties installed.

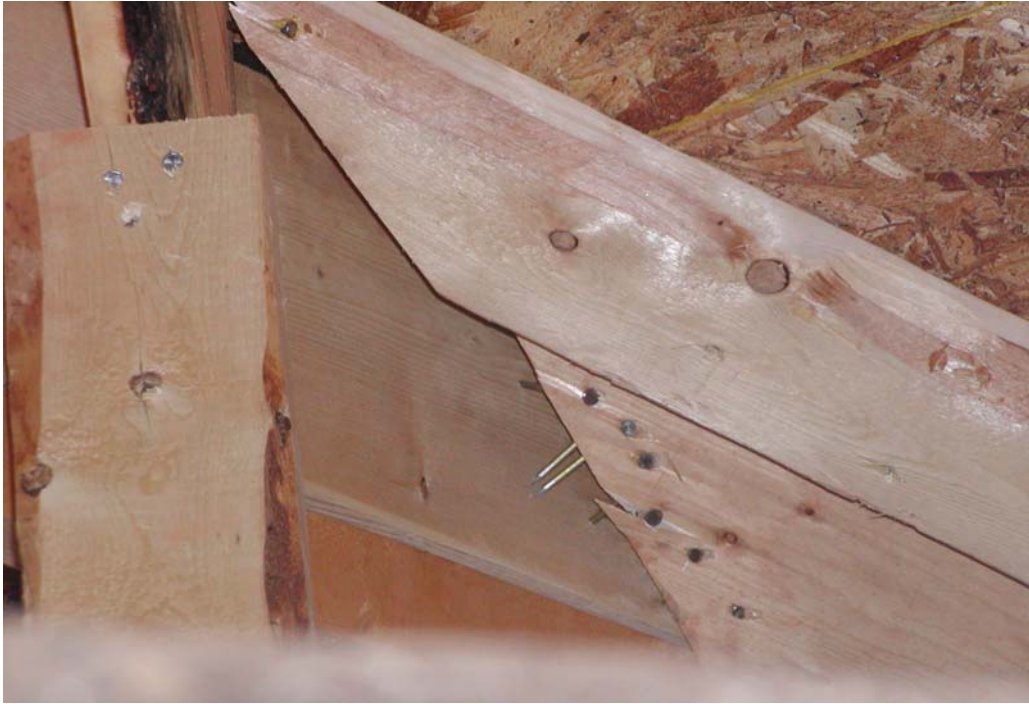
Incorrect Hip and Valley ridge connections. (Too much nail showing and non flush attachment to be of full strength for design)

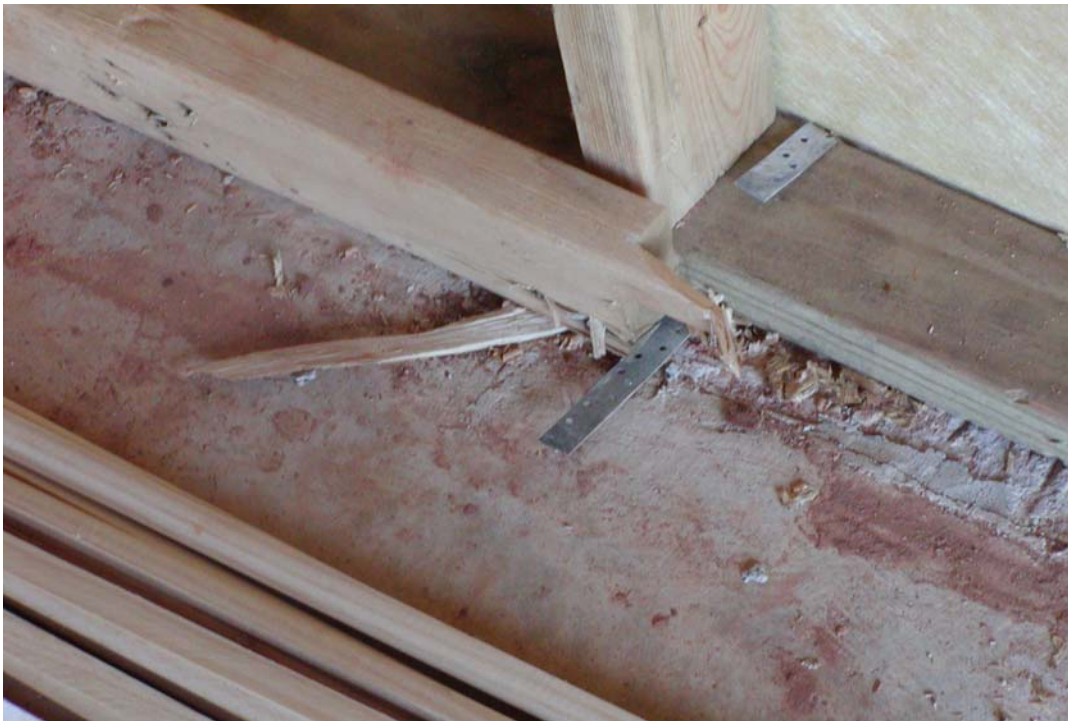
Foundation straps are not all properly secured to sole plate.

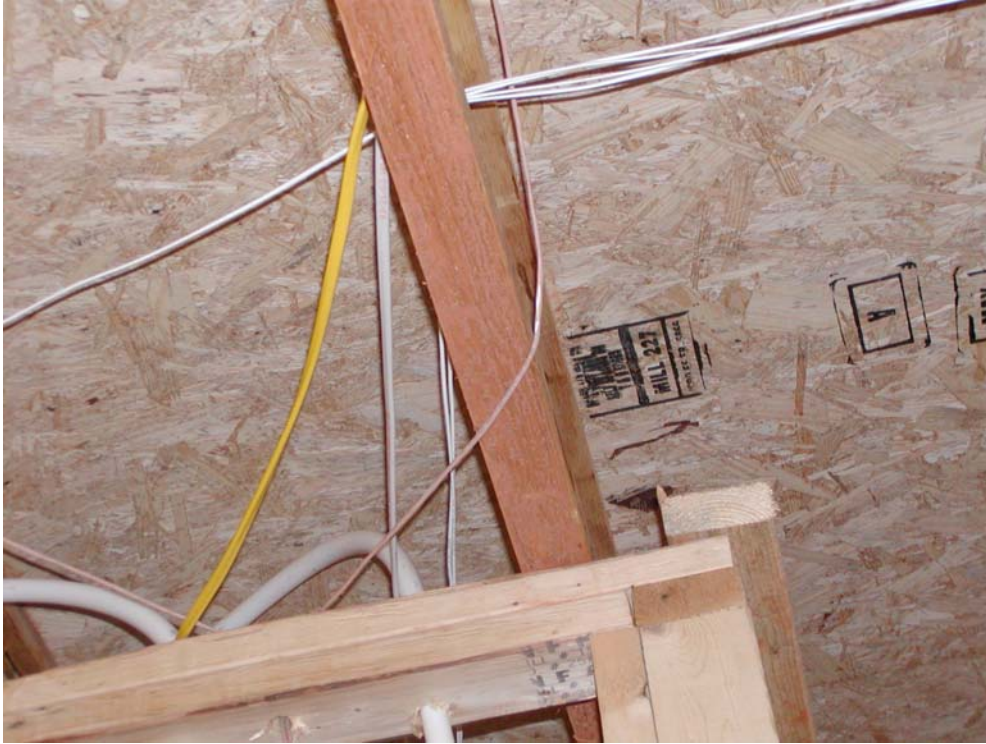
Low voltage wire is routed on the underside of floor joist. Re-route to avoid damage in next phase of construction schedule.

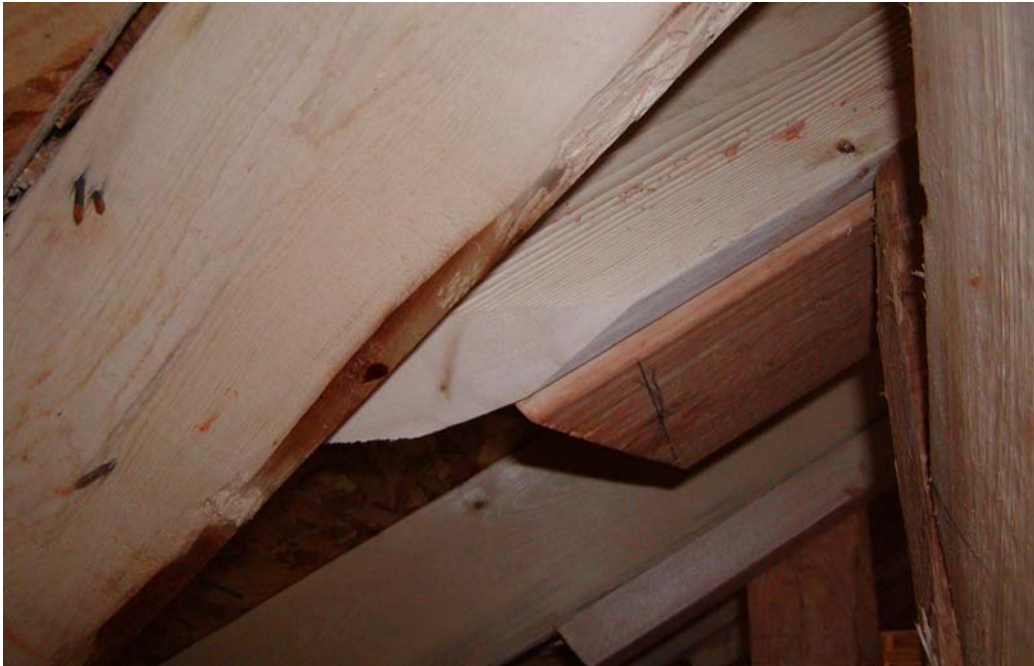
C) Valley Rafters are smaller than the end cuts of rafters throughout the house.

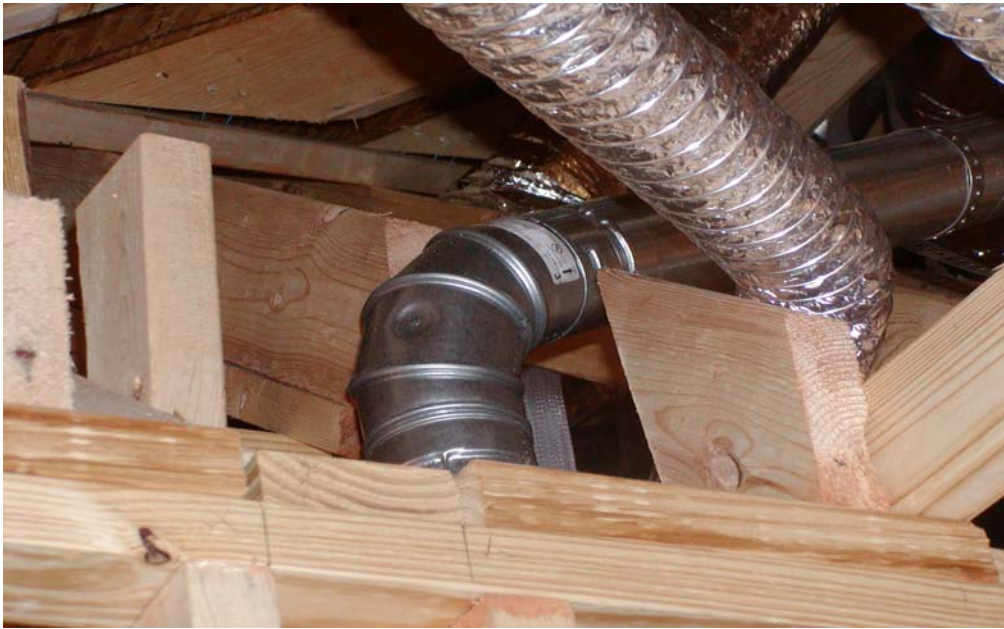
D) Rafter is cut to allow a vent from the water heater to pass through.

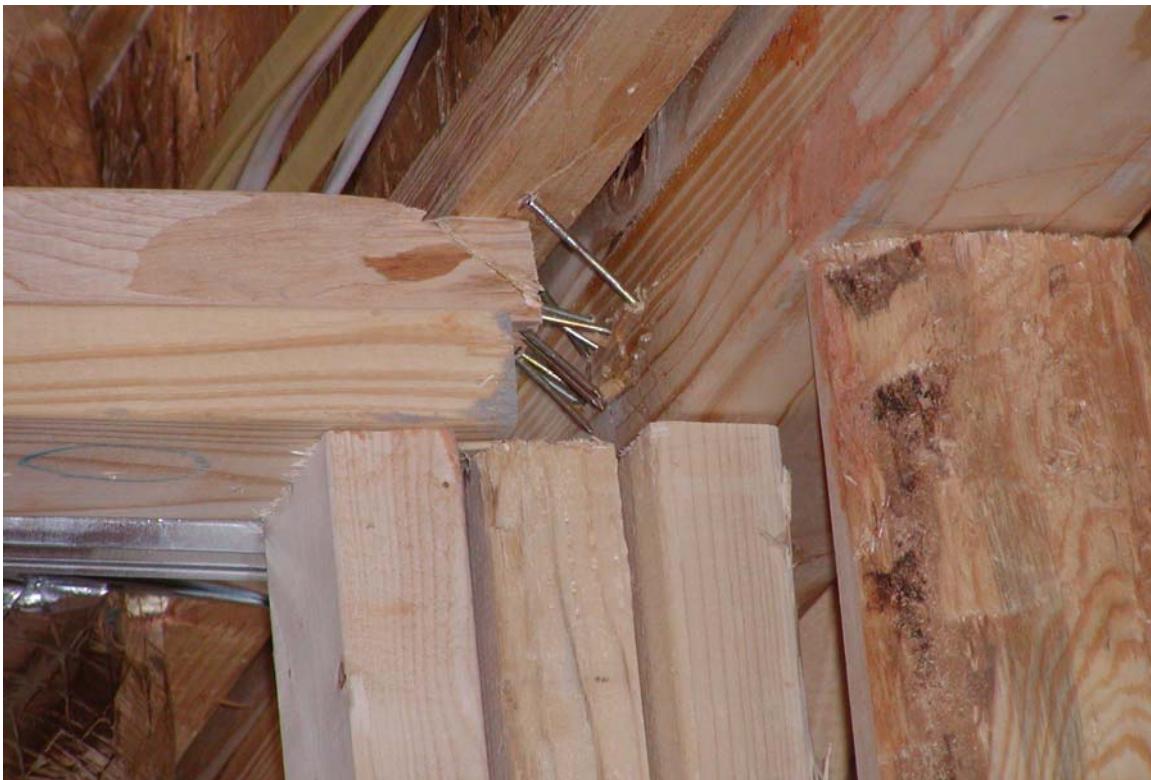
Poor installation of top plates and fastening.

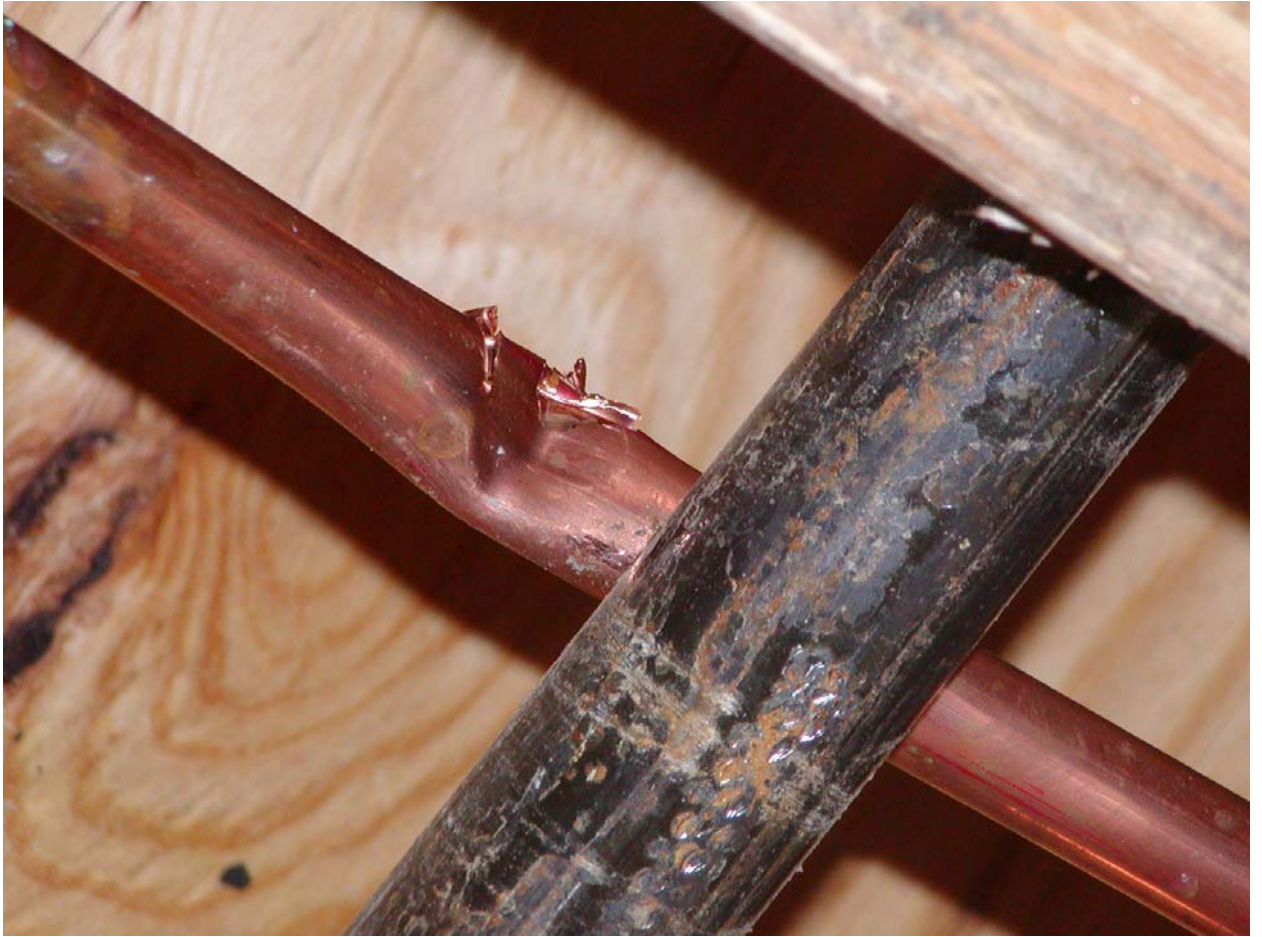
Copper water pipe damaged.
