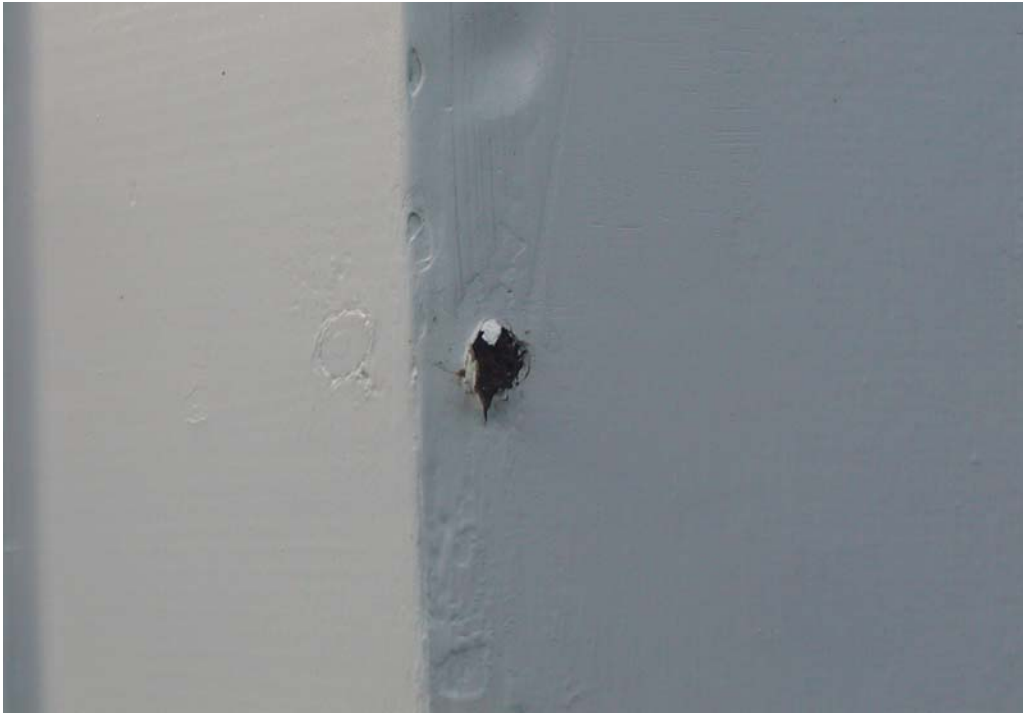
Wood trim on bay window at right side of structure is partially decayed and painted over.

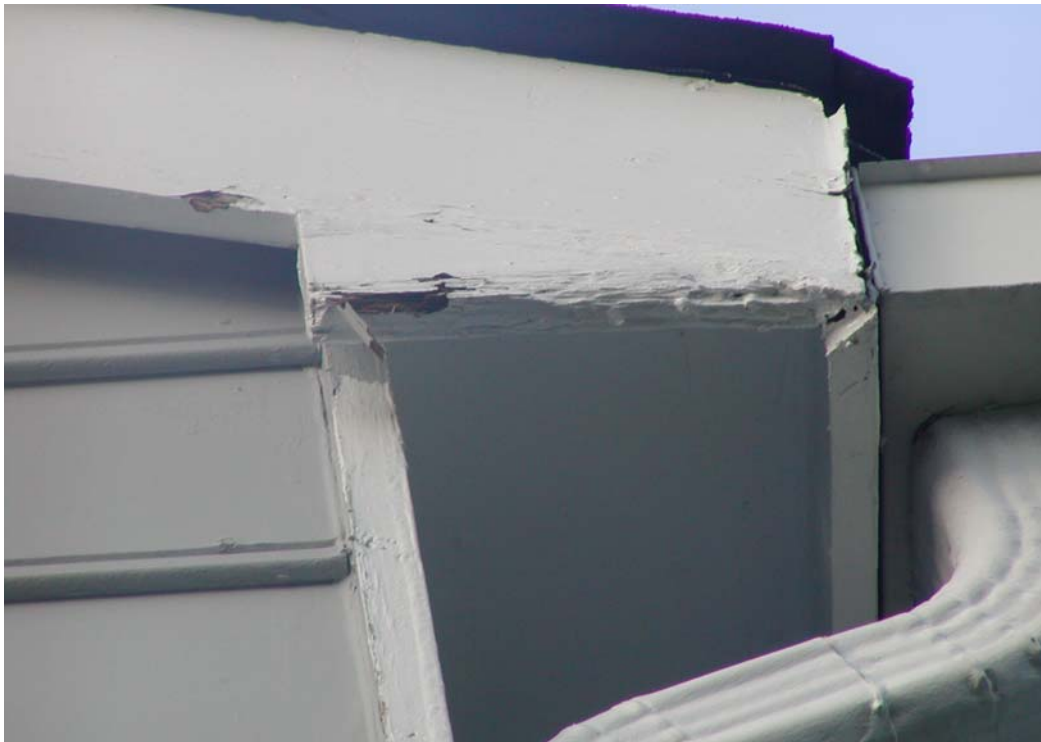
A fascia board on right side of house has decayed wood that has been painted over.

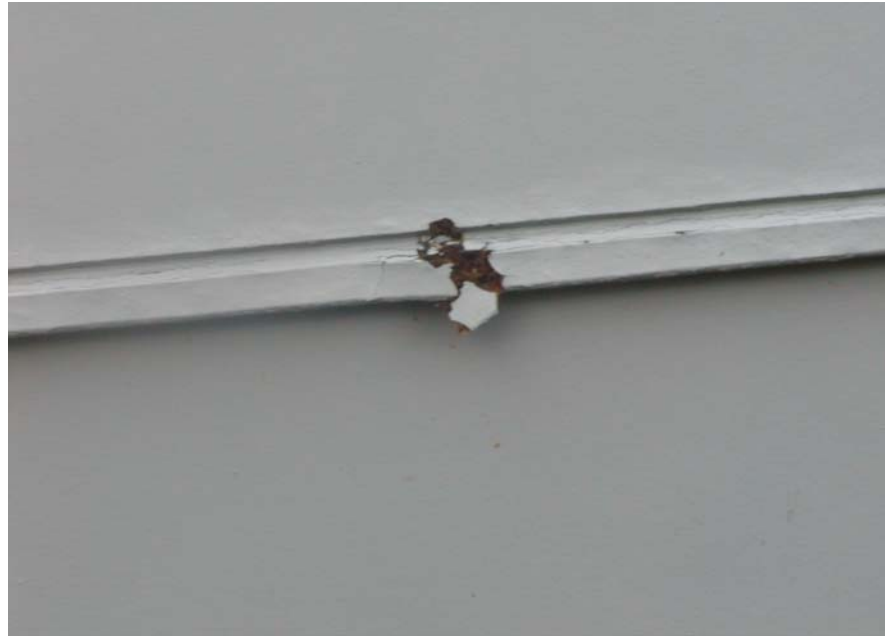
Hardboard Siding is delaminating and in some cases has painted over decay.

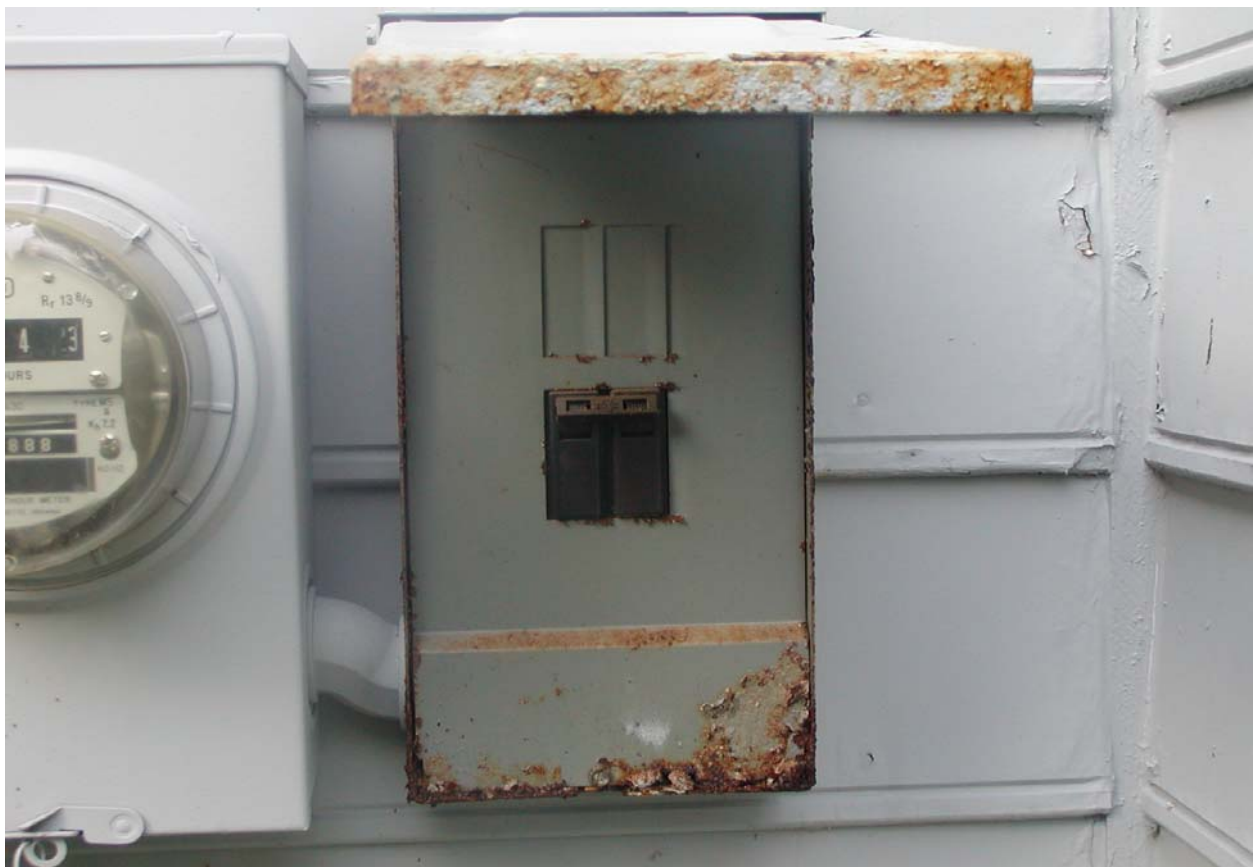
Main disconnect box (housing) is in need of repair. Box is heavily corroded and apparently not water tight.

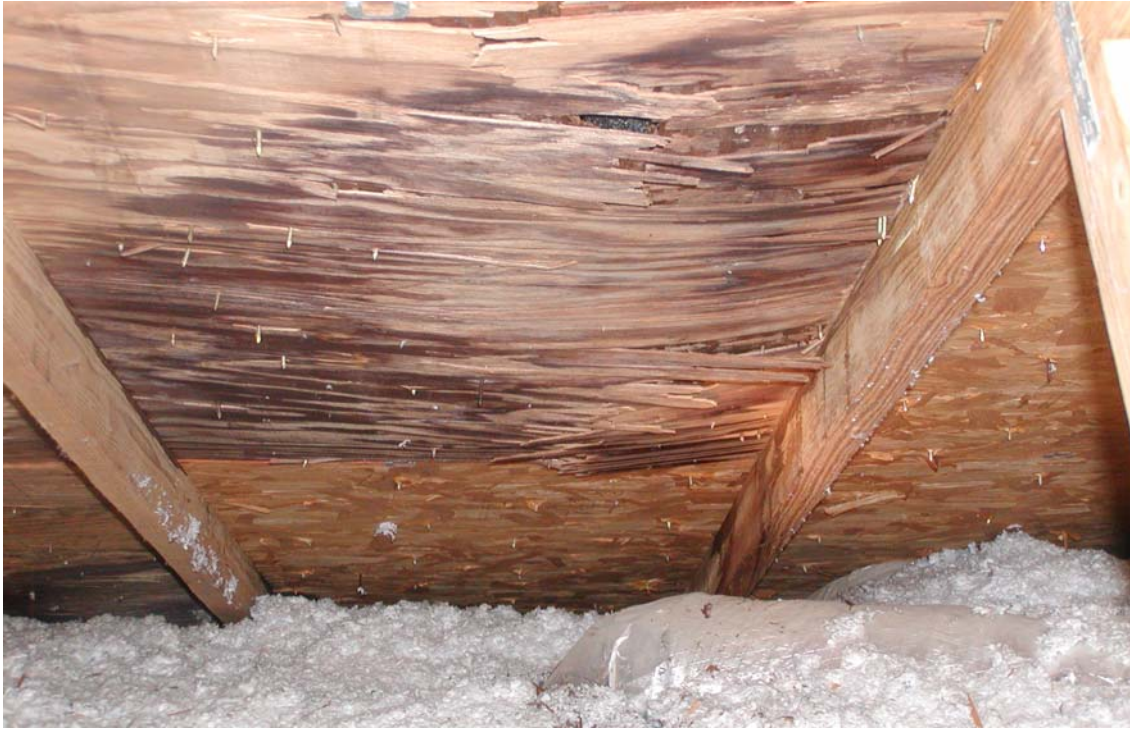
Roof decking has severe damage noticeable from the inside. Damage apparently caused from leaks that have been repaired without replacing the decking in two spots.

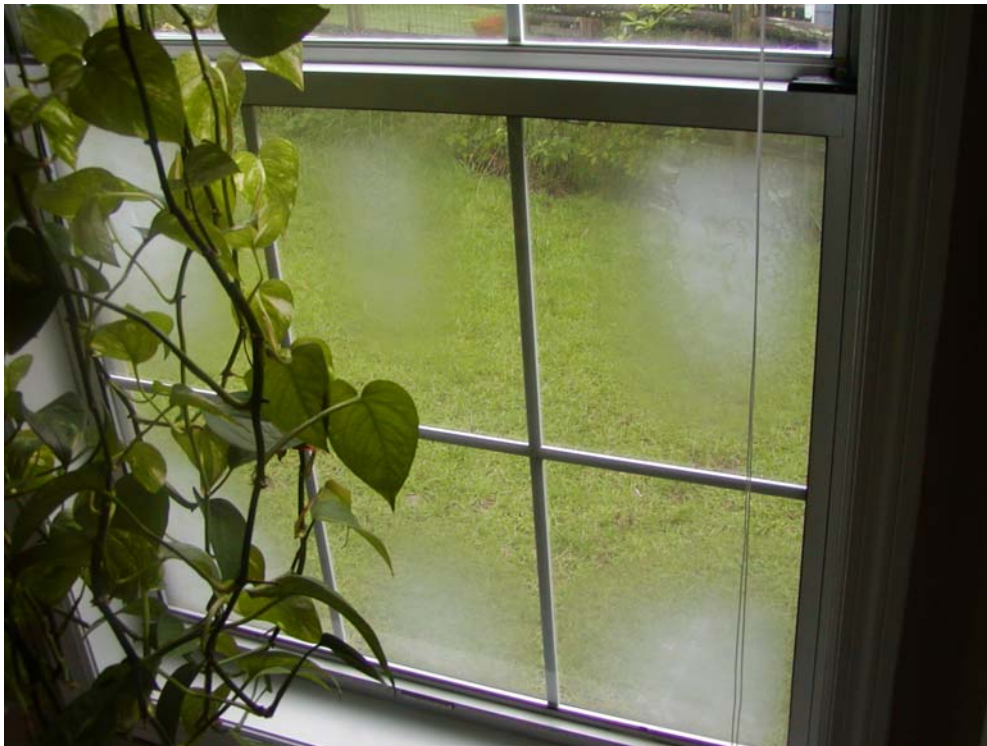
Window on right side of structure in bay area is fogged, indicating a leak in the thermal pane assembly.

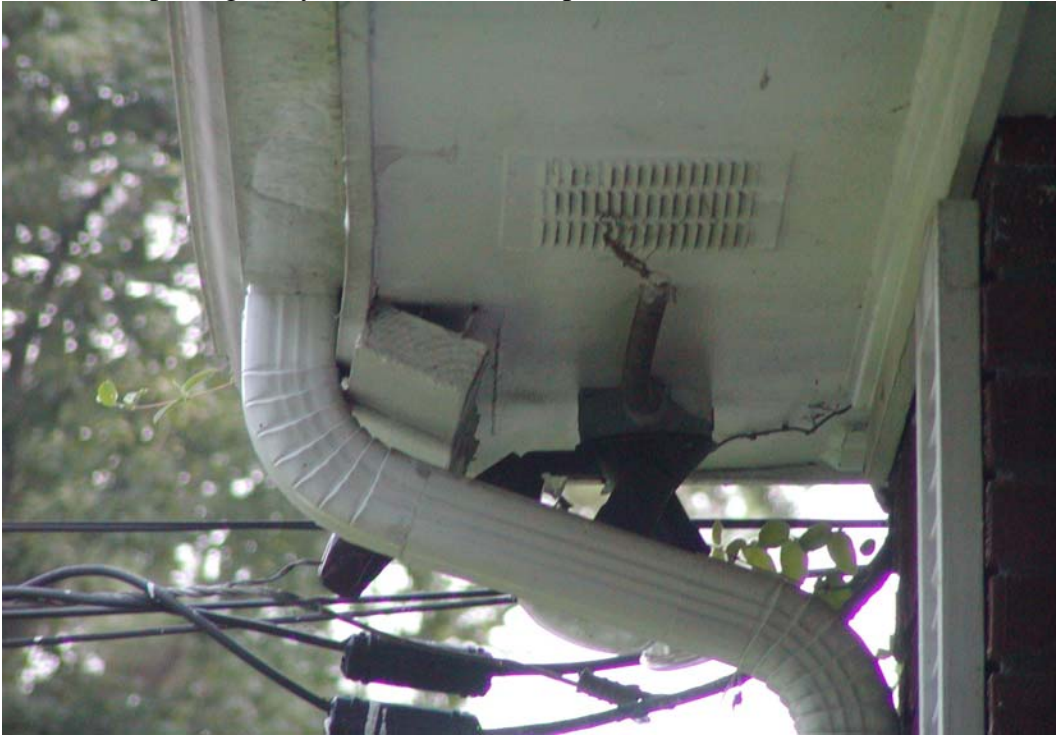
Fascia board is pulling away from house where power cables attach to house.

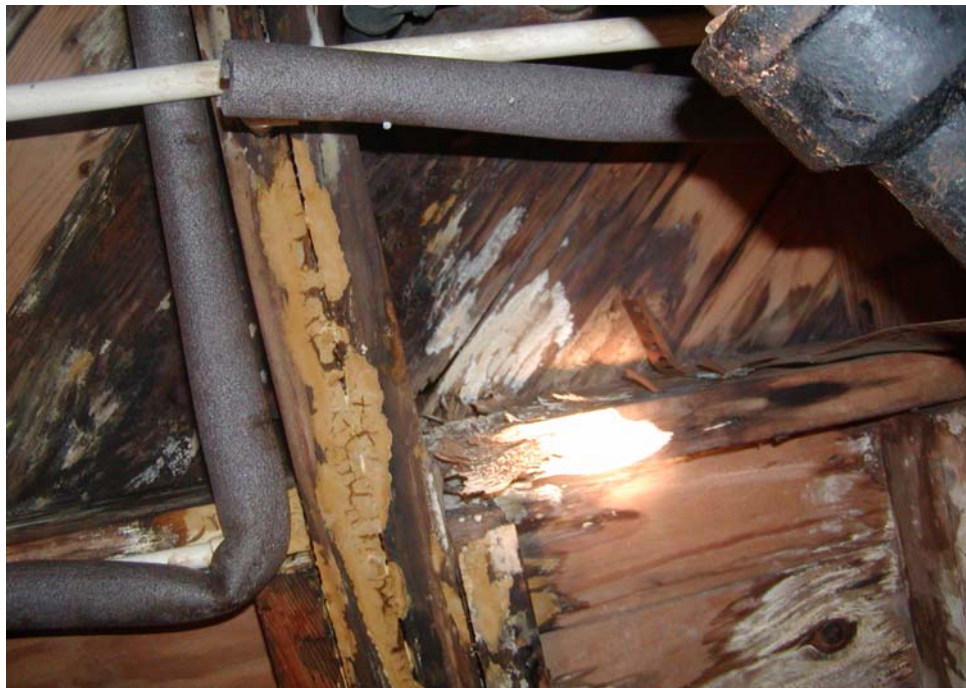
(Needs immediate attention):

Some rot of wood structural members is present under the bathroom.

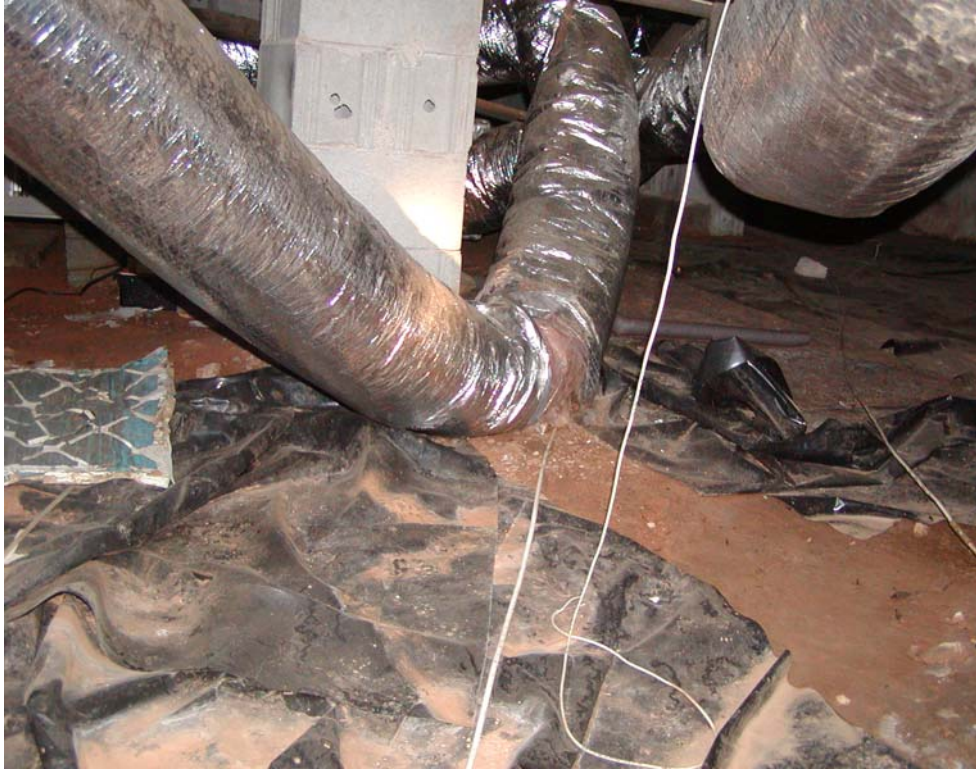
Some A/C duct is lying on the ground. (Repair)

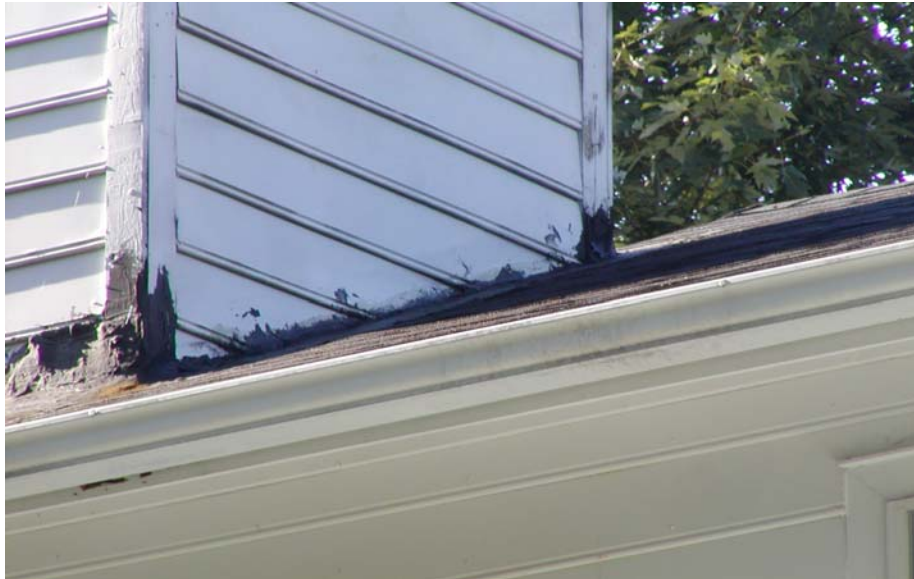
Chimney flashing is not properly installed; flashing should be installed under the siding and roof covering and counter flashed to divert water away from chimney.

If properly installed and flashed, asphalt shingles do not require the use of tar which is used for leaks near the chimney.

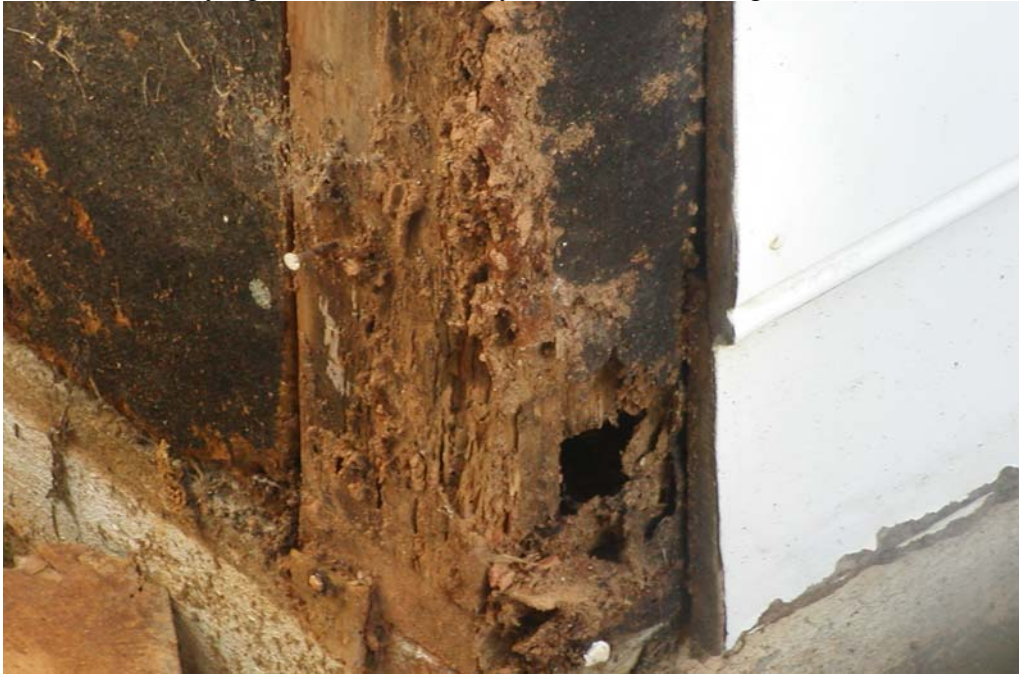
Signs of wood destroying insects on chimney frame under siding.

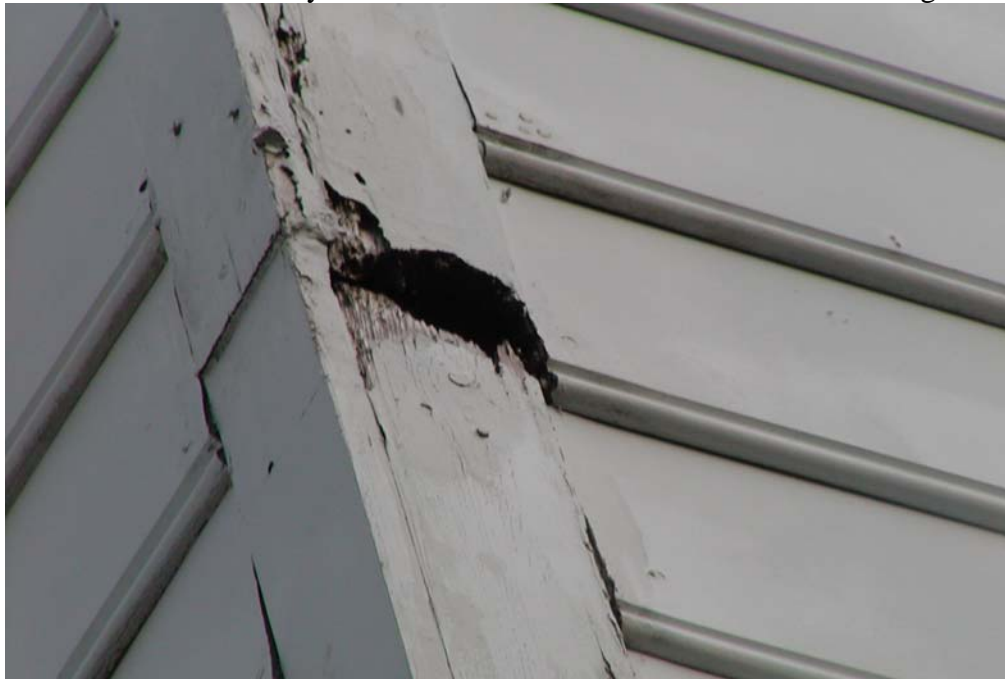
Water rot observed at chimney and in various areas around the structure near ground.

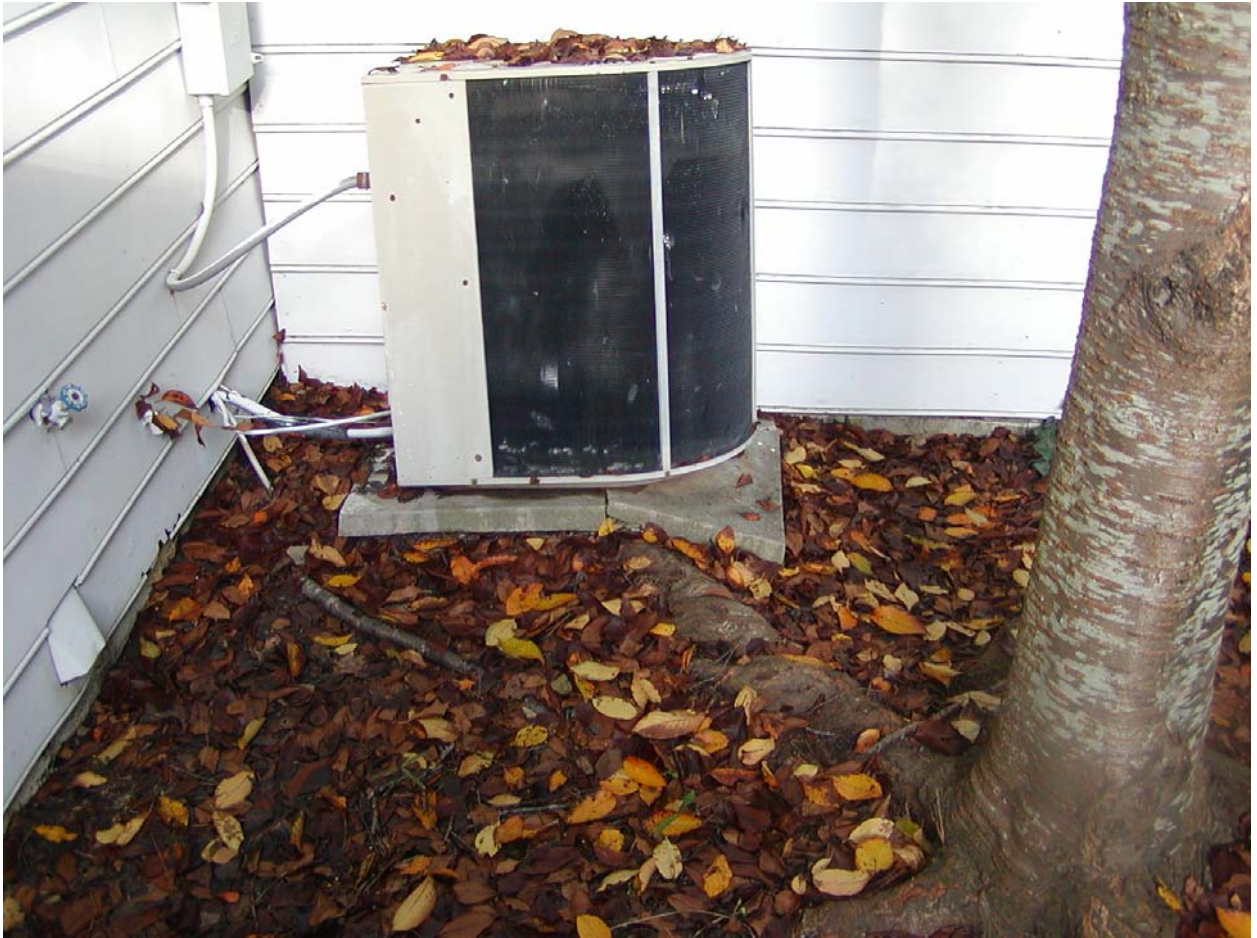
A/C Unit is un-level due to root form tree that is located too close to structure.
