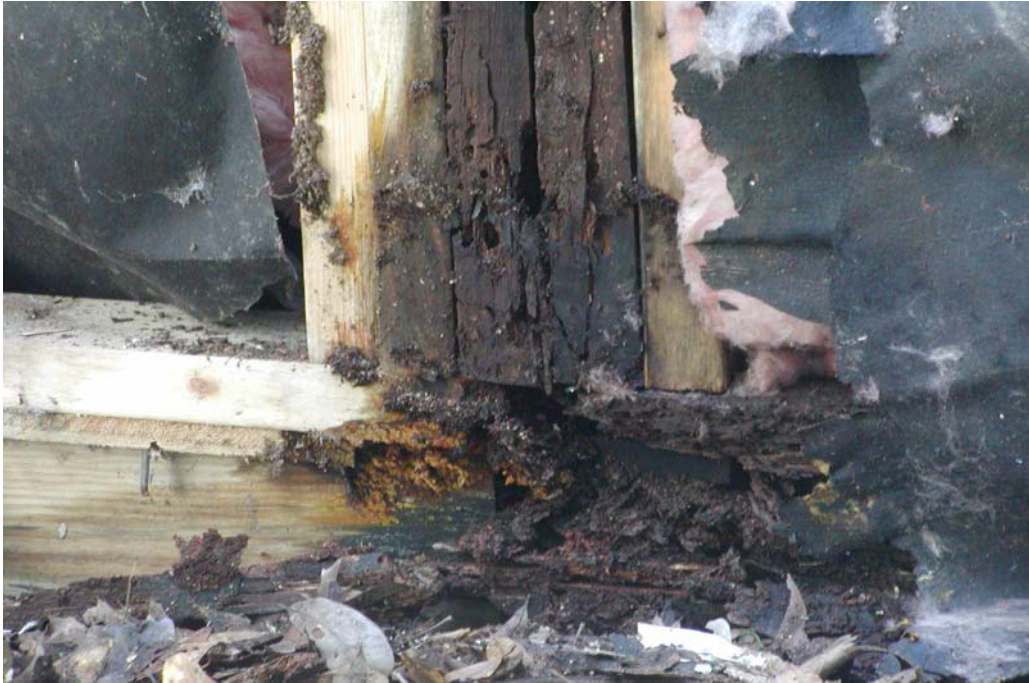
This photo shows prior repairs that were incorrect. What we have is new wood that has been placed on top of wood with rot. All decayed wood should have been replaced.

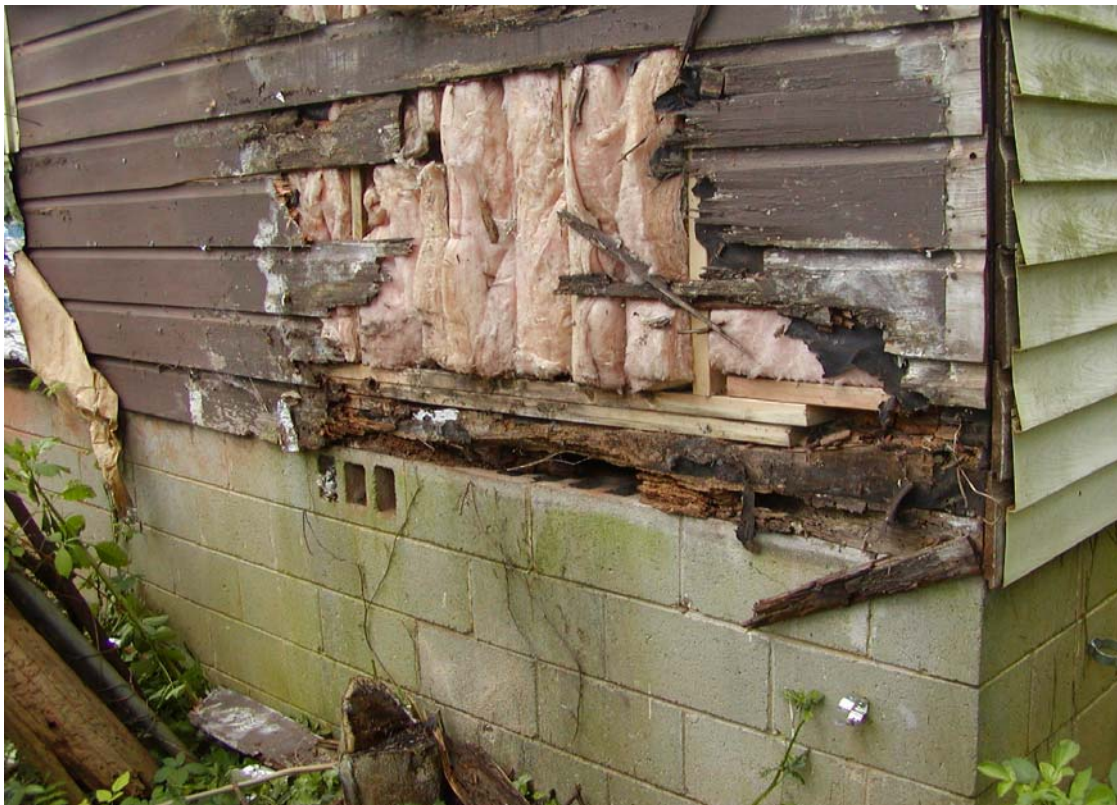
More new wood on top of rotten wood.

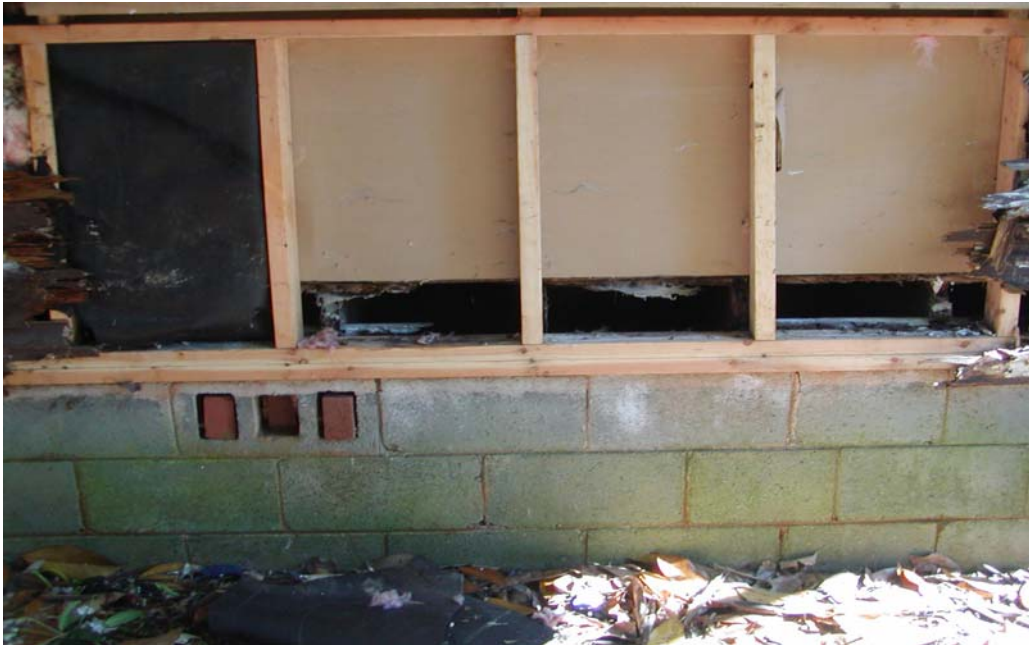
This repair was incorrect due to the non pressure treated wood coming in contact with concrete blocks, plus the floor has not support on the outer edges. There should have been an outer floor sill made of pressure treated wood.

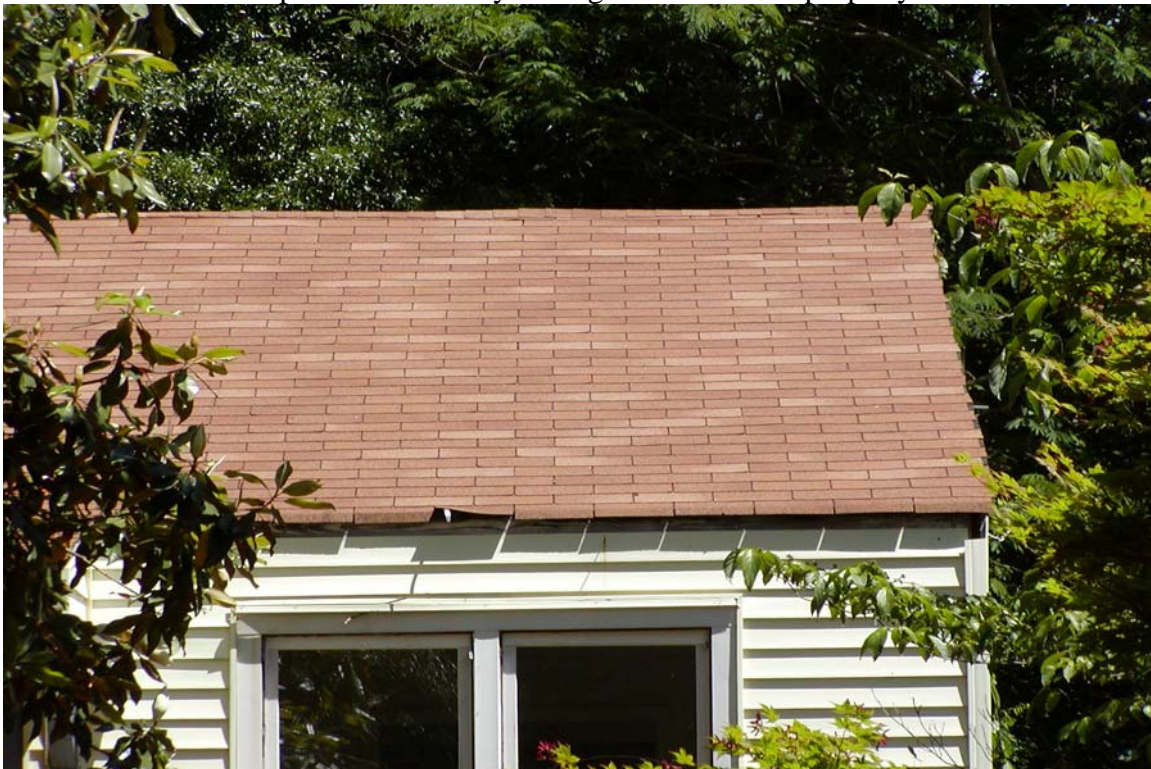
Part of the root cause of all of this wood decay under vinyl siding is improperly installed asphalt roof shingles. There was no starter shingle used which allows rain water to flow between the tabs and penetrate the vinyl siding which was not properly installed either.

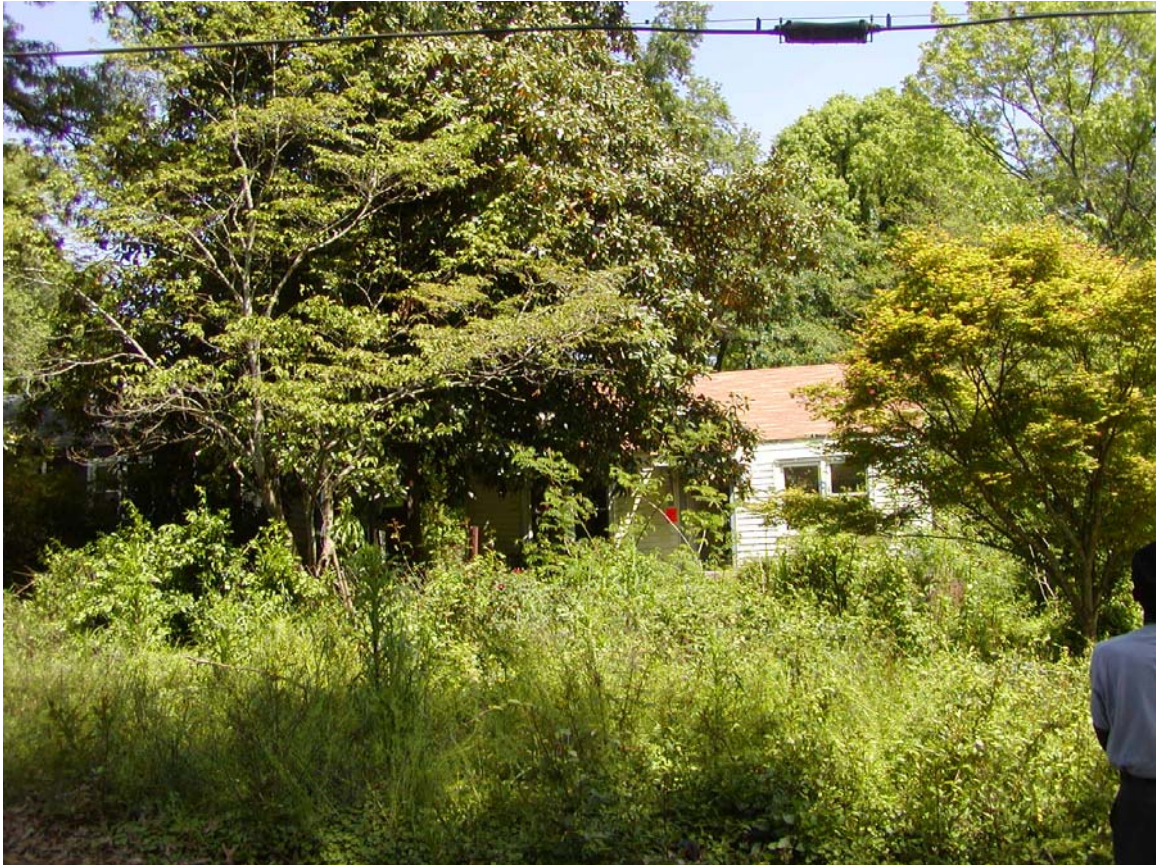
Before

The photos at the top of this section are of this house which is condemned and in non livable condition. After a considerable investment and a watchful eye, this structure is sound and in very livable condition. All phases of construction were permitted and a new certificate of occupancy has been issued for this property. At last communication with the owner, he is very pleased.
(See the After photo next page).

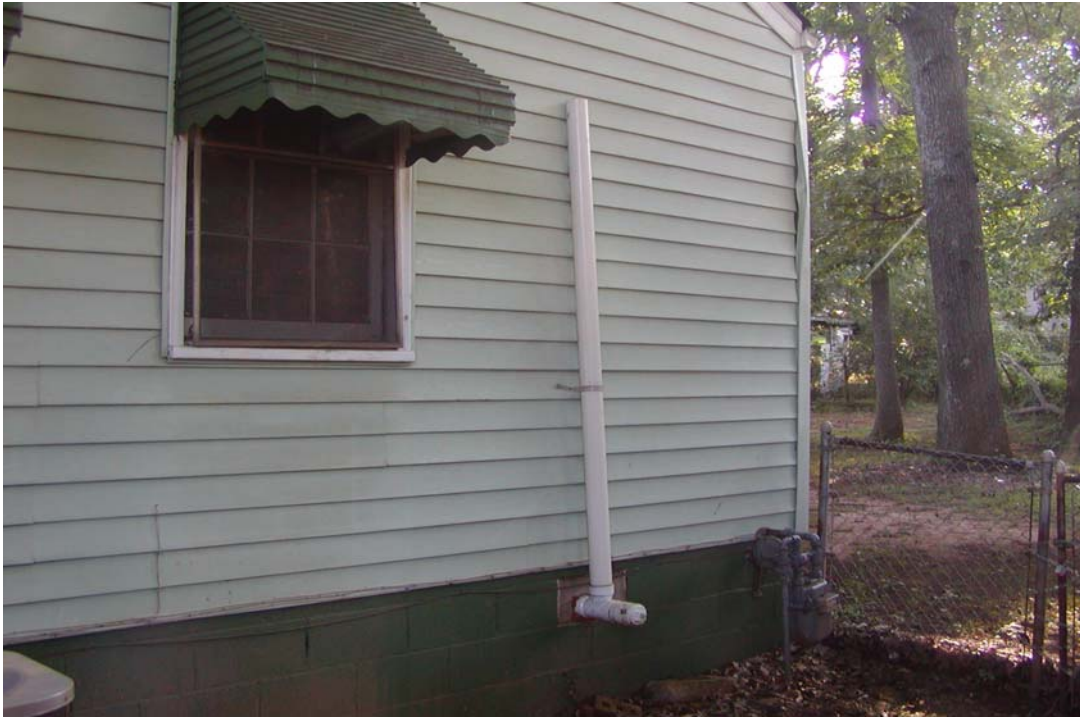
Sewer vent on right side of structure does not extend above roof.

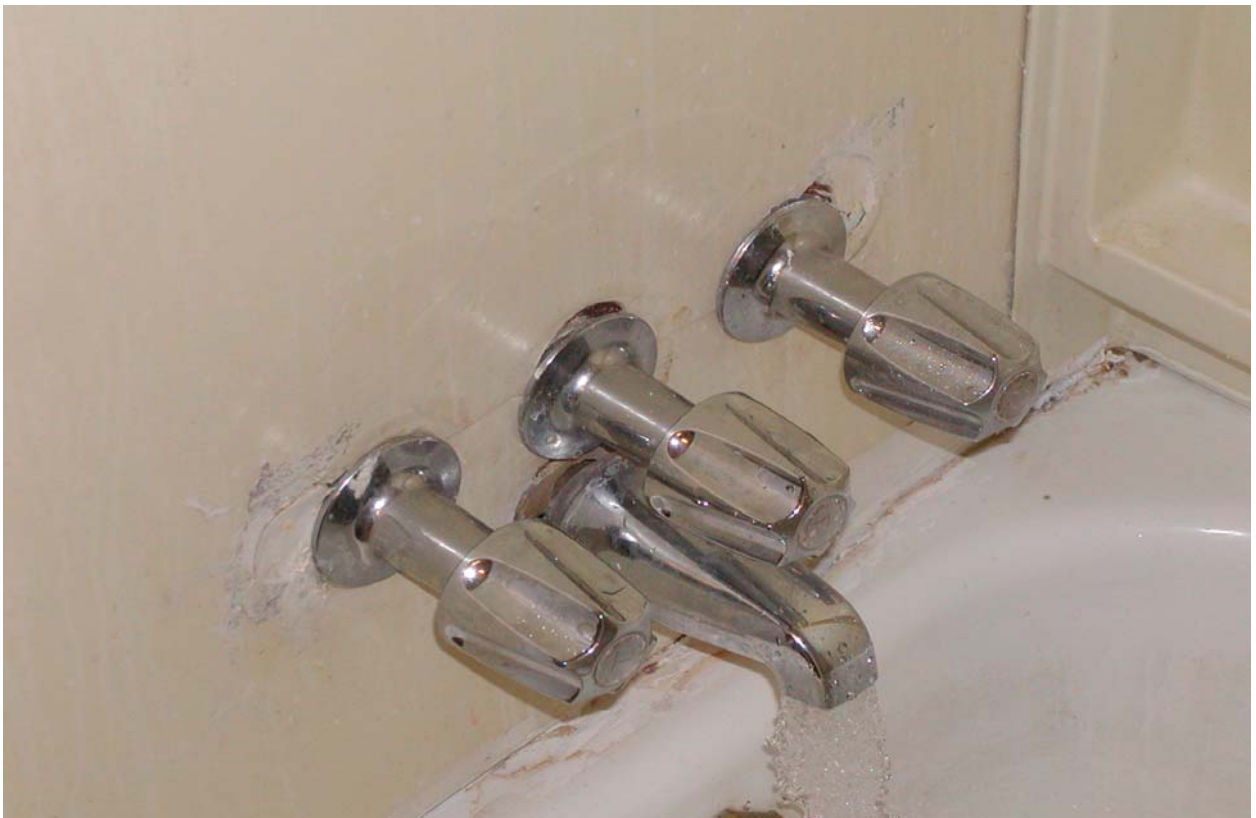
Tub and shower faucet is not properly secured.

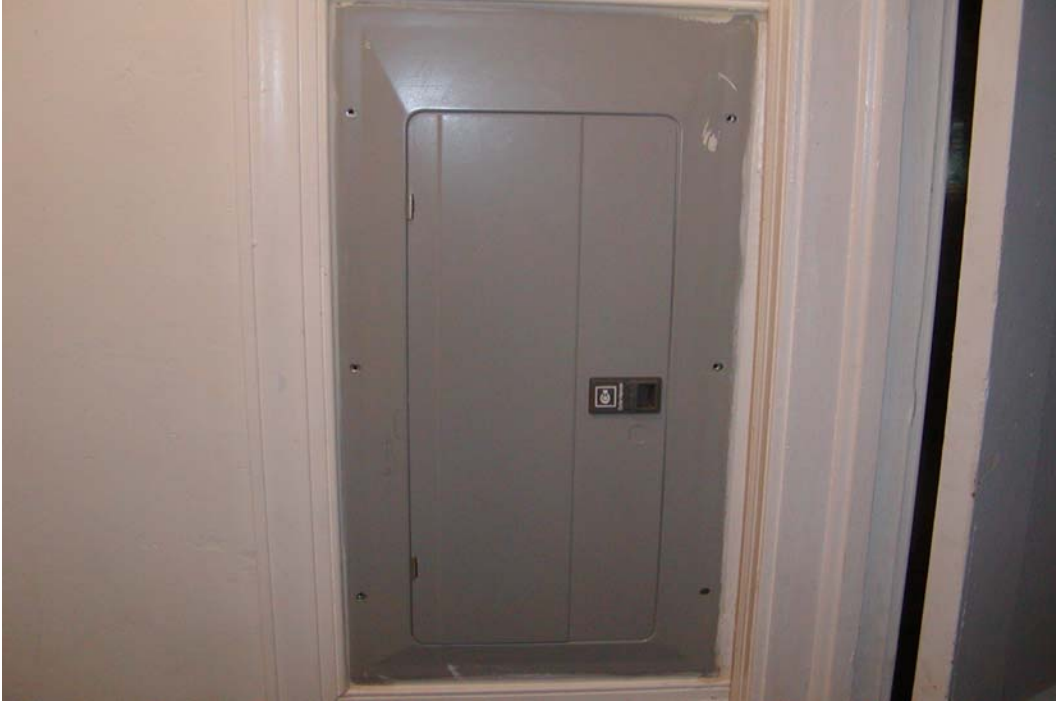
Internal parts of the electrical panel are not accessible, trim that is around the panel face restricting access. (Make Accessible).

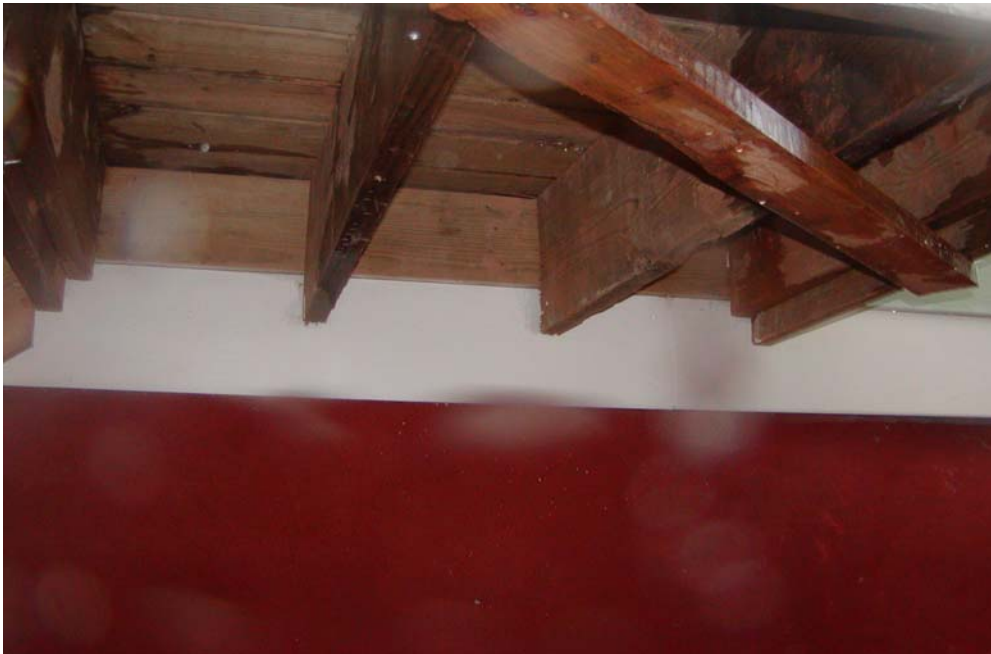
Floor joists are not properly supported by joists hangers or a ledger board. No positive attachment to structure with lag bolts.

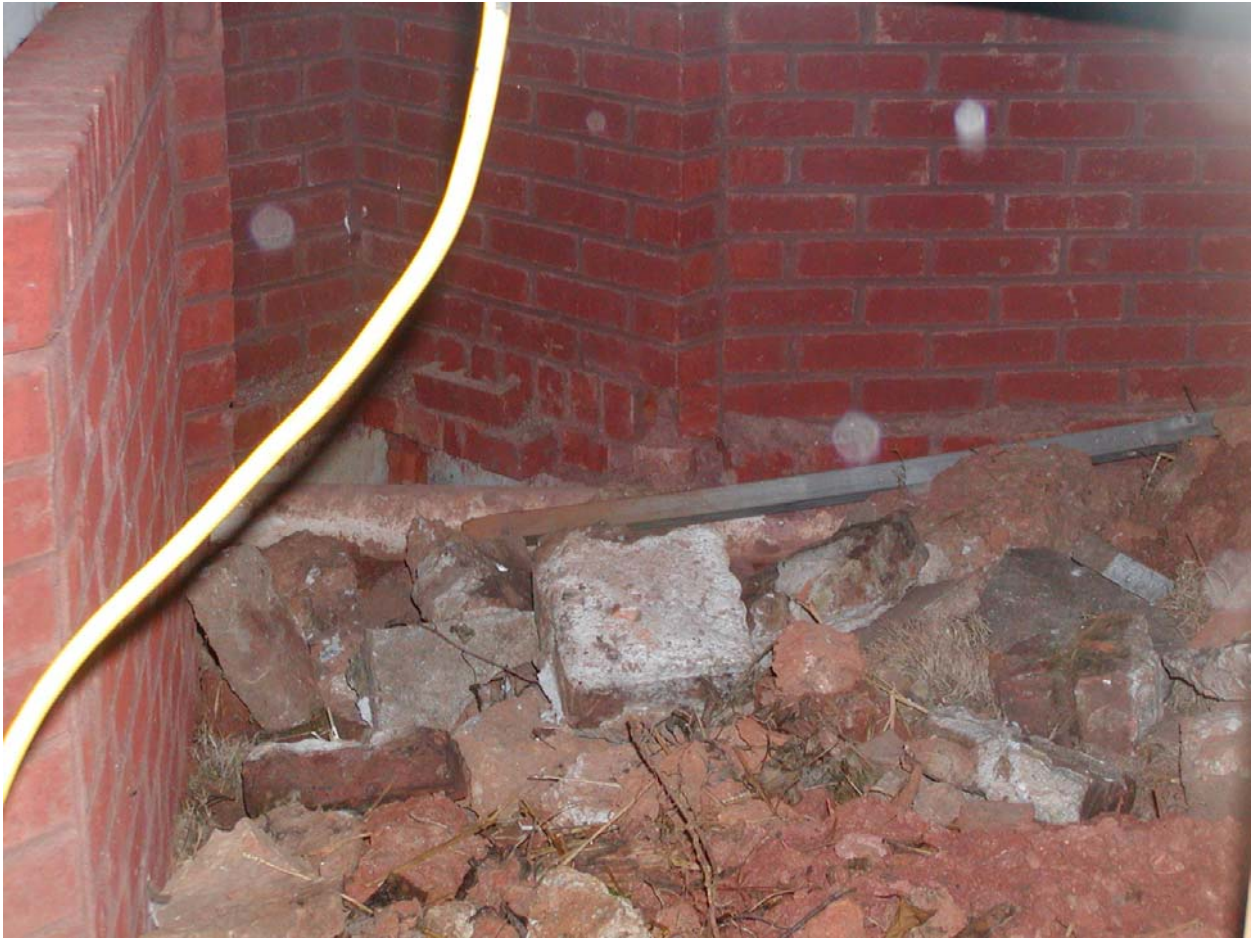
Area under front porch has lots of debris and is sloped negatively.

Fill dirt should be placed under porch and sloped away from structure.

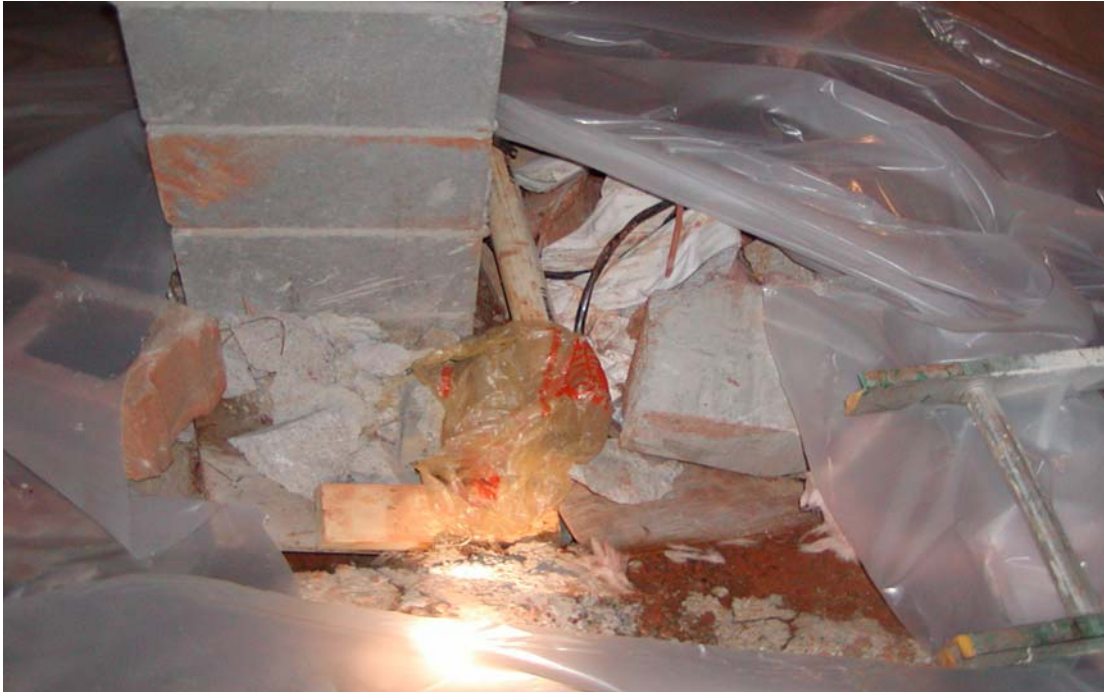
Debris is scattered over crawlspace underneath plastic vapor barrier.(Remove)

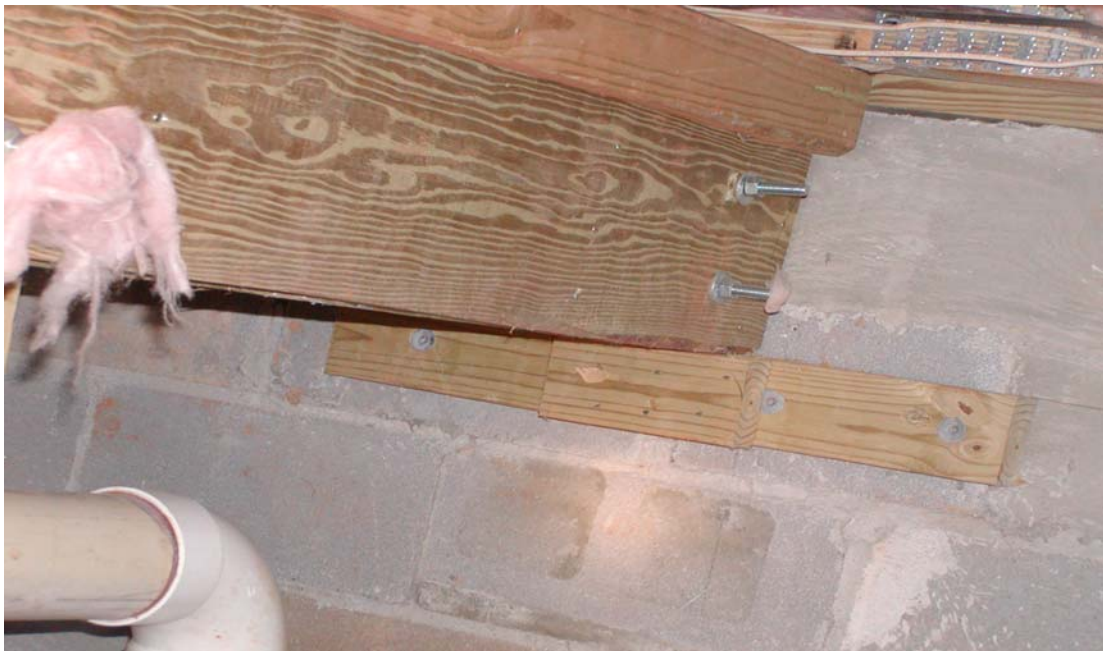
Girder has inadequate support at the end spans where Girder butts up against the wall.

This method of framing is unacceptable. One end is supported by 2x4 blocks that are mechanically attached to foundation wall.

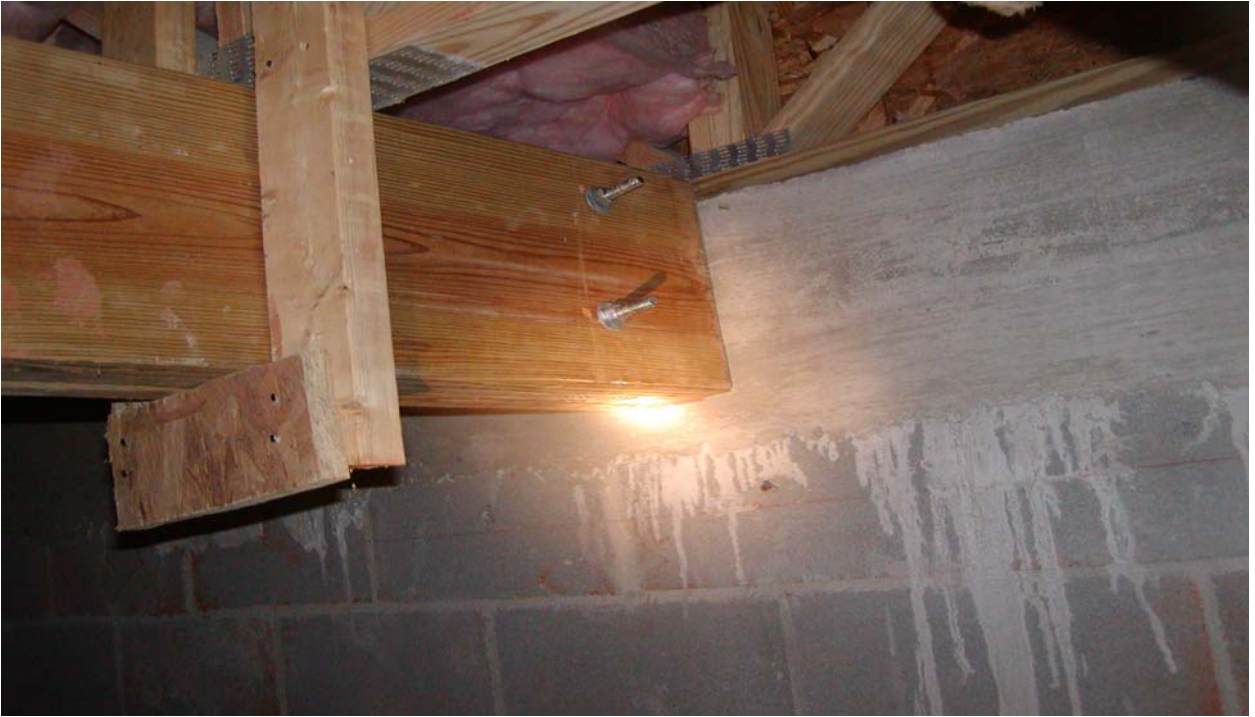
The back end of Girder has makeshift support that is an unacceptable construction practice.

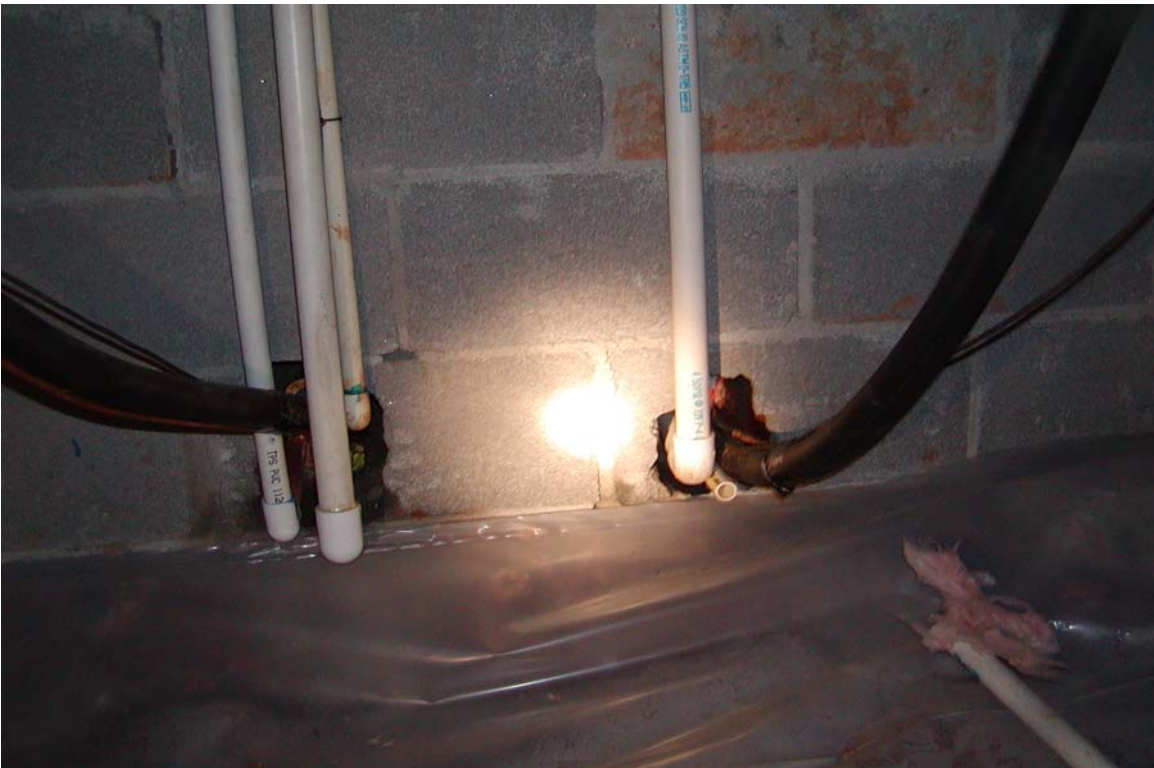
Drain pipe from A/C unit is not continuous to the outside and will discharge into the crawlspace.

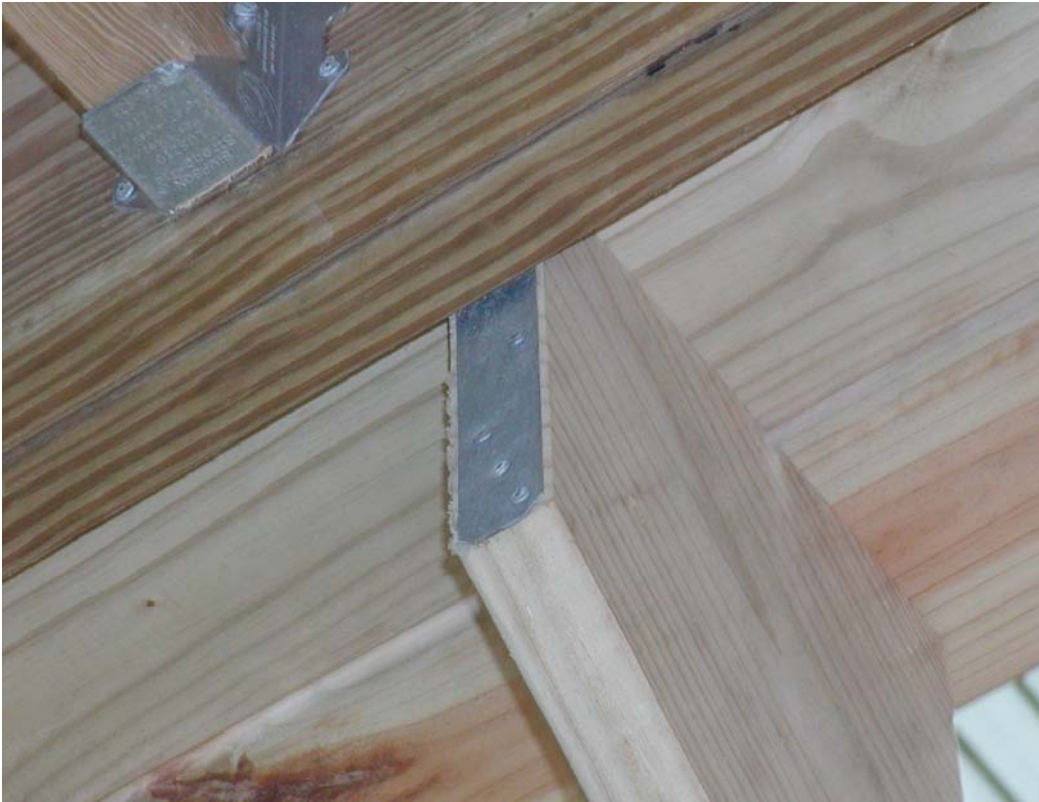
Stringer attachments are inadequate. The upper set of steps has the wrong type of metal strap attachment, stair stringers are too short, and there is no bottom support for stair stringer.

The proper type of joist hanger or stringer attachment should be, Simpson Strong Tie (LSU 26).
